## APPENDIX A: LAKE STUDIES

### UNDERSTANDING OSS�PEE'S LAKE SYSTEM OVER THE CENTURIES

Green Mountain Conservation Group ~ 10-Year Water Quality Report

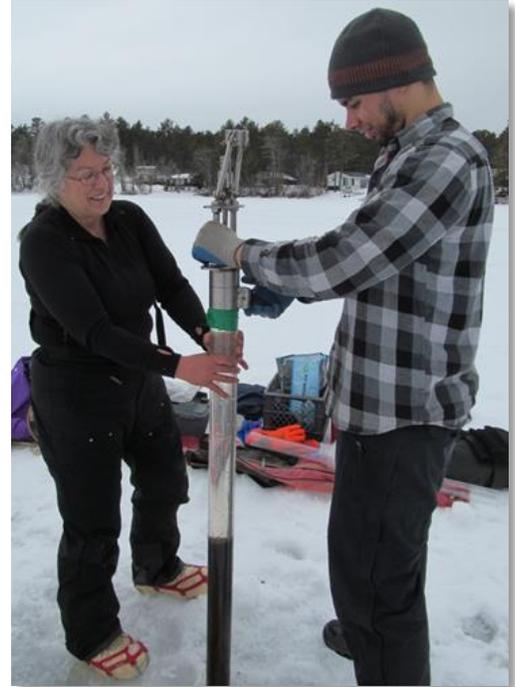
Sediment cores from the bottom of the lake provides information about what the conditions were in the lake over the past several centuries. (Photo: Lisa Doner)
